The Industry's Most Definitive Pole Fire Fact Sheet

By John Lauletta, CEO & Founder of Exacter, Inc.

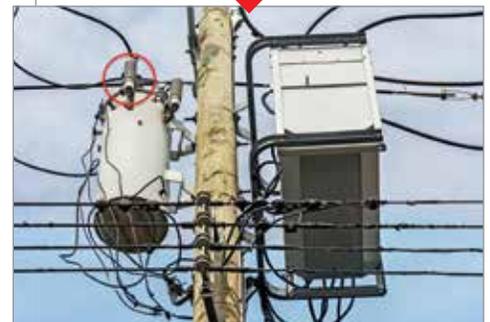
How Exacter Technology Detects Partial Discharge. Exacter's patented technology is placed in vehicles or aircraft. As lines are travelled, Exacter identifies partial electrical discharge on your overhead system. Points are GPS marked. Lines are assessed 3-4 times to confirm problem. Field teams are sent to locations with ultrasonic detection devices to identify the pole and specific component emitting the partial discharge. All report data is GIS-compatible and includes maps, photographs and video confirmation of the problem.

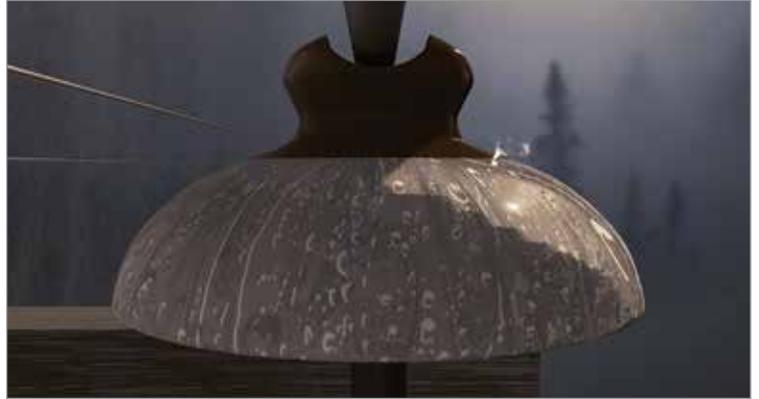
▶ *Contaminants adhering to surface of components form dry bands which create conductive pathways for leakage current.*

1. Salt, dirt, dust, fire ash, bird feces and other contaminants from the environment adhere to the surface of components.
2. This begins to breakdown insulation properties (BIL) of the insulator, arrester, cutout, or even transformer causing minor current leakage.
3. Diverged axial currents will cause the growth of a dry layer of these contaminants on the surface, further impeding insulation properties.
4. Most of the applied voltage tracks across the contaminants forming a pathway for leaking and arcing current. Light rain, fog or drizzle, exacerbates the problem.
5. As the leakage current bleeds into the wood and makes its way to ground, it dries the wood.
6. The leakage current also heats up the through-hole bolt that holds the crossarm to the pole.
7. As the metal bolt heats up, it accelerates the drying of the wood, eventually combusting and causing the pole fire.

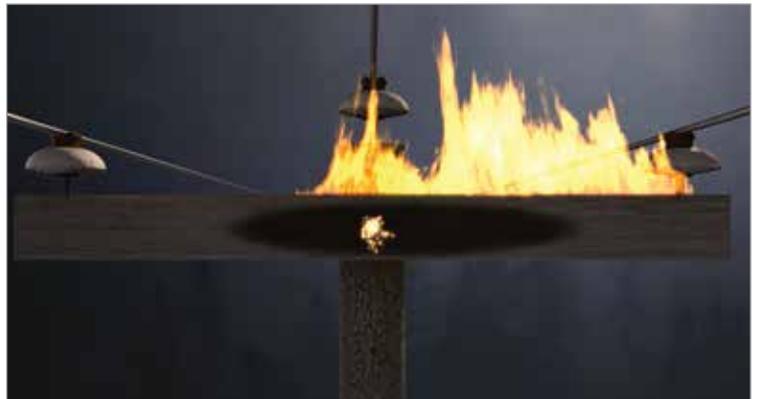
▶ *After through-hole bolt heats up over time, combustion can occur and start the pole fire.*
